## ABOVE GROUND STORAGE TANK REPAIR IN-SERVICE

#### CASE STUDY SIDE WALL TANK REPAIR

#### 3 EXAMPLES OF TANKS REPAIRED USING FORGE TECH TECHNOLOGY

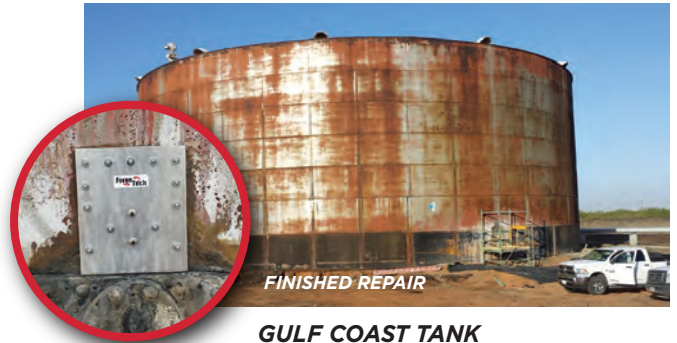
**GULF COAST TANK  
ON-LINE REPAIR**

*The assests structural integrity was restored  
instead of being allowed to degrade.*
